**RICHELIEU RIVER BASIN
STOWE, VERMONT**

**LAKE MANSFIELD DAM
VT 00100**

**PHASE I INSPECTION REPORT
NATIONAL DAM INSPECTION PROGRAM**

MARCH, 1979

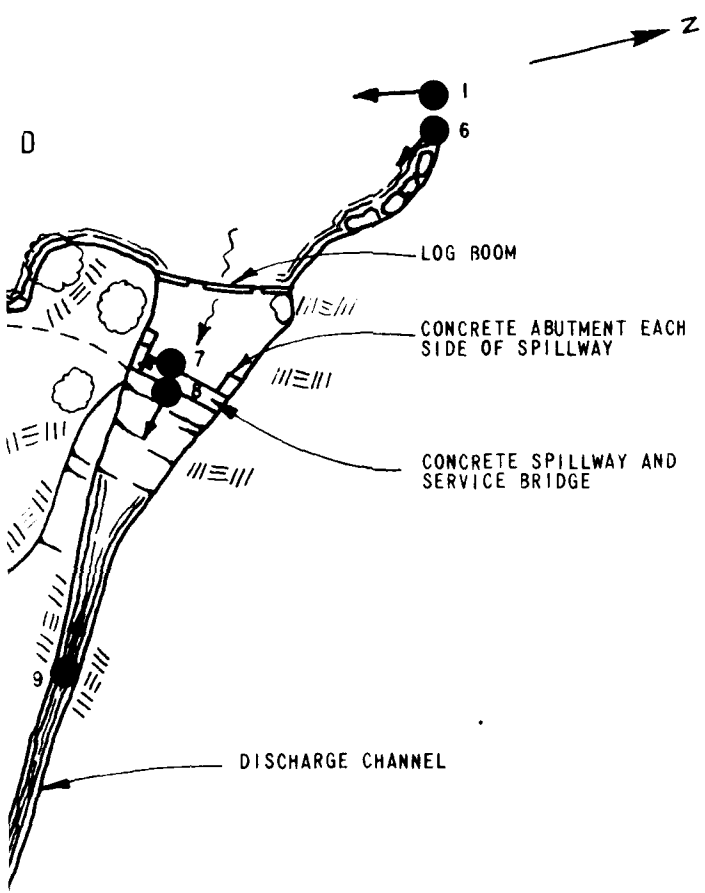
- 1 ICICLE ON DS INVERT IS CLEAR. NO FLOW.
- 2 1-3 GPM VERY RUSTY WATER. WAS COVERED WITH STONES WHICH WERE MOVED TO OBSERVE WATER.
- 3 NO WATER EVIDENT
- 4 FILLED WITH WATER. FROZEN. NO FLOW.
- 5 3-6 GPM FLOW. CLEAR BUT RUSTY STAINED ZONE DOWNSTREAM AS SHOWN.
- 6 WET ZONE. NO FLOW OBSERVED.
- 7 SMALL STREAM EMERGING FROM NATURAL HILL. PROBABLY A CONTINUATION OF STREAM BELOW RIGHT ABUTMENT.
- 8 SMALL SEEP << 1 G.P.M.
